# **Environmental Exposure Effects on DOT-CFFC Cylinders with Modal Acoustic Emission Examination**

**JUNE 2015**

US DOT/PHMSA  
Mark Toughiry, PE  
1200 New Jersey Ave, SE  
Washington, DC 20590  
+1 (202) 366 – 4545

Digital Wave Corporation  
Dr. Brian Burks, Dr. Steven Ziola, Dr. Michael Gorman  
13760 E Arapahoe Road  
Centennial, CO 80112  
+1 (303) 790-7559 x13

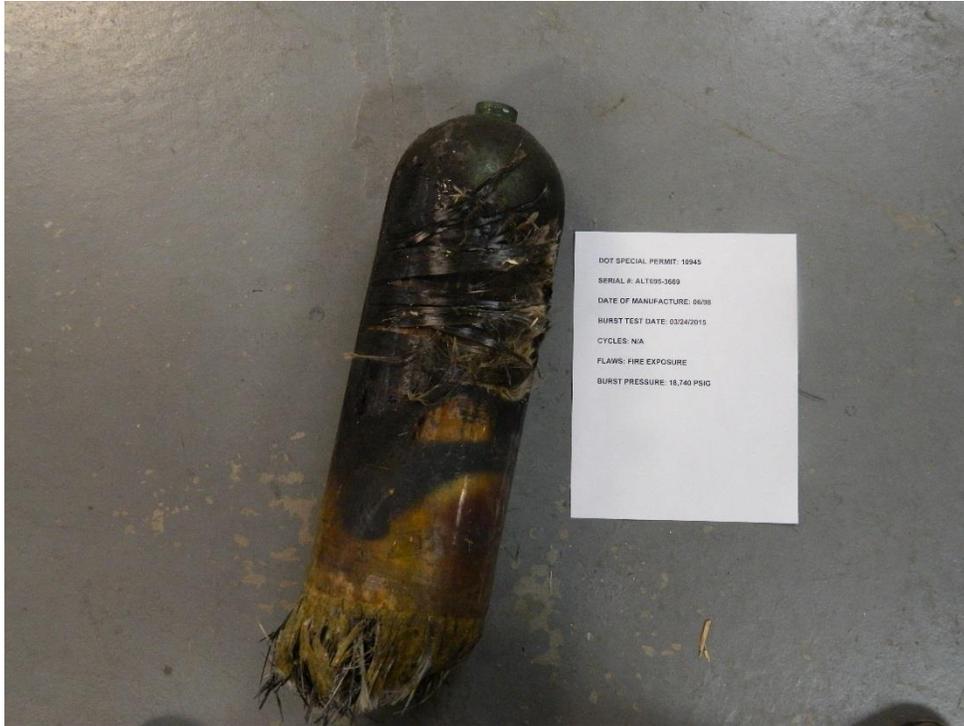
Figure E.43 – End-of-Life burst of ALT695-3669.

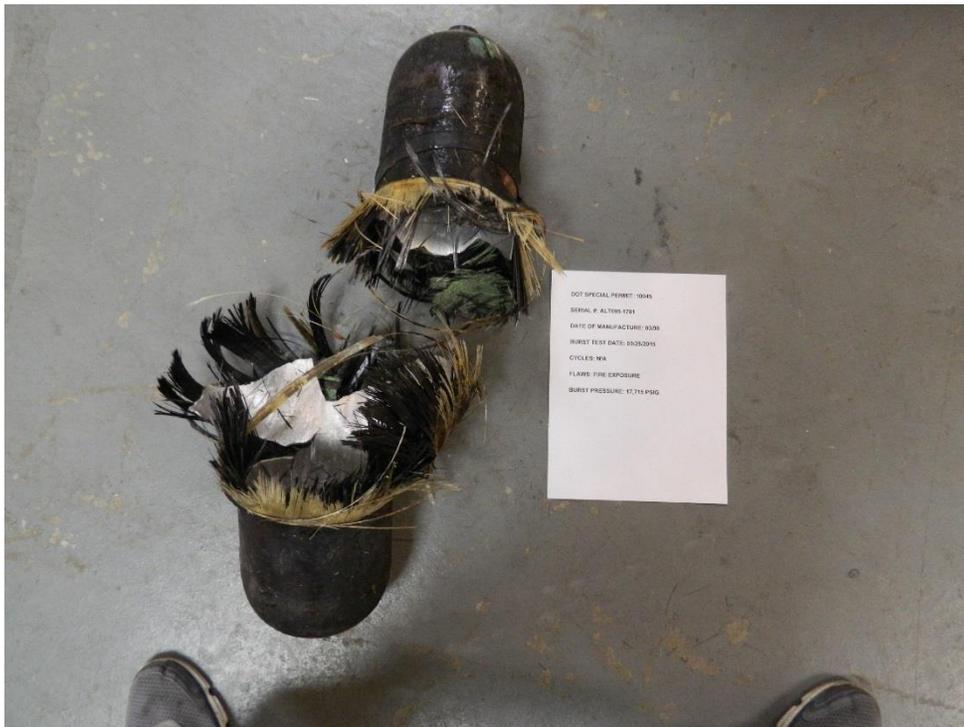
Figure E.44 – End-of-Life burst of ALT695-1781.

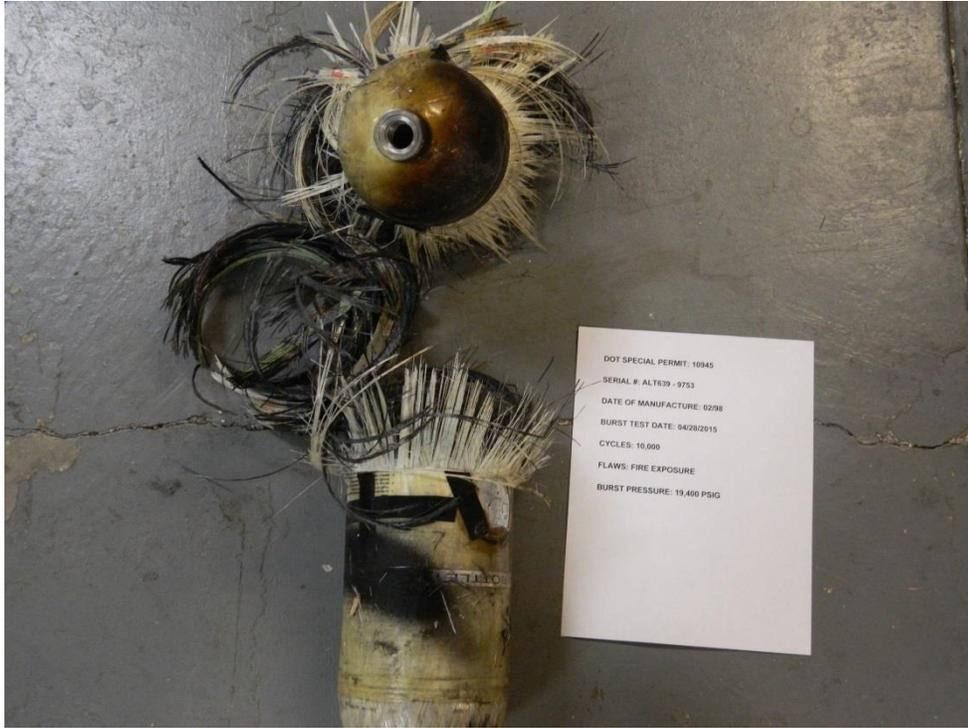
Figure E.47 – End-of-Life burst of ALT639-9753.

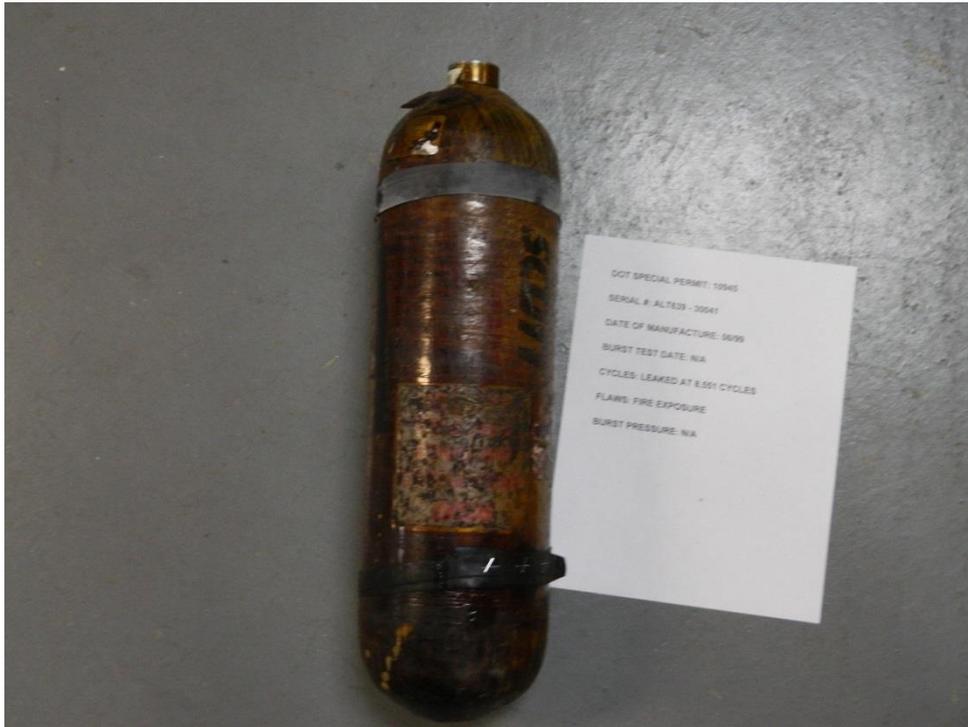
Figure E.48 – End-of-Life burst of ALT639-30041.
